ACCIDENT

| Aircraft Type and Registration: | Eurocopter EC135T1, VP-CPS | |
| Date & Time (UTC): | 26 February 2019 at 1631 hrs | |
| Location: | Owen Roberts International Airport, Cayman Islands | |

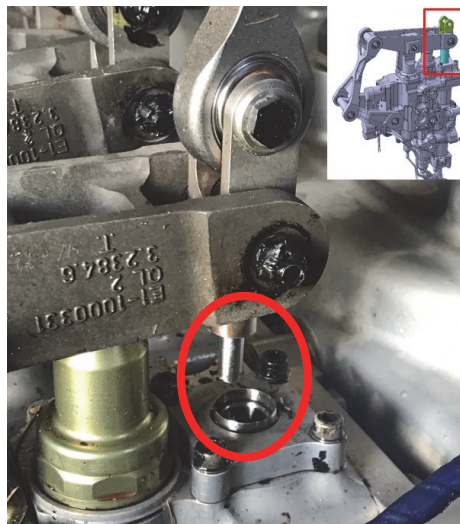
Figure 1

The crew exited the helicopter unaided and the aircraft was made safe without further incident. A maintenance team arrived at the helicopter and found damage to the landing gear, tail boom, Fenestron shroud and the transmission deck. Further investigation revealed that the tie bar of the longitudinal axis actuator had broken near the fork end (Figure 1).

Longitudinal axis actuator prior to removal from VP-CPS

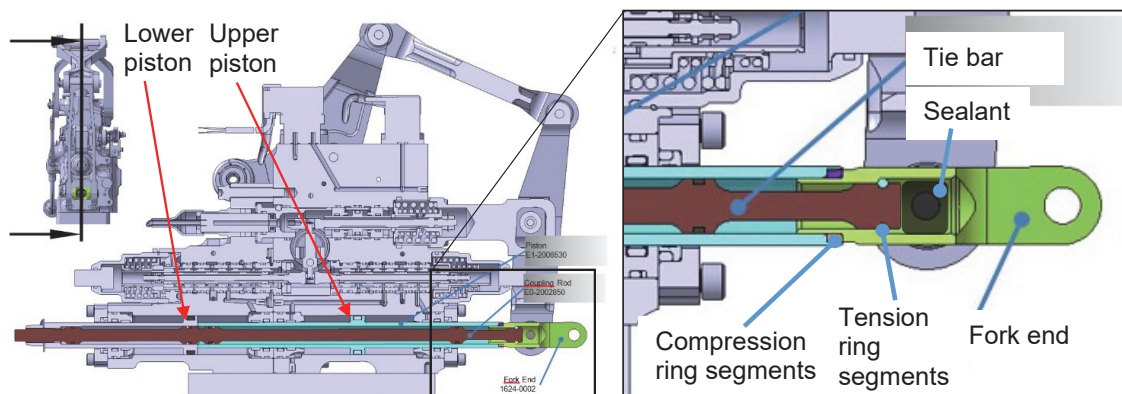
Figure 3

The MRA is installed vertically and, depending on control input, the actuators either push upwards or pull downwards on the swashplate linkage. Inside each individual actuator are two axial pistons, one per hydraulic system, which are linked with a tie bar (Figure 3). This bar is manufactured from passivated, high-strength, corrosion-resistant steel, and attached to a fork end which connects to the swashplate linkage. Tension loads from the pistons are transferred to the fork end by the tension ring segments and compressive loads are transferred through the compression ring segments. Sealant is applied to the centre bore of the fork end to prevent moisture ingress into the upper piston through the tension ring segments.

Cross section views of a single axis actuator from the MRA (rotated)

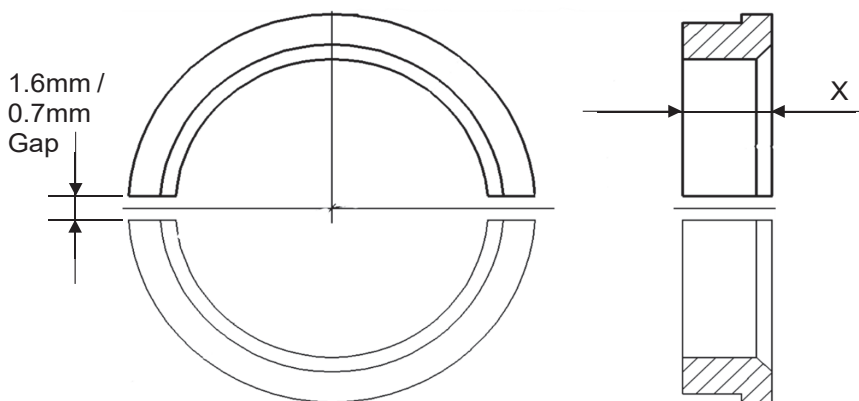
Figure 4
Compression ring segments

Two half-segments are used to remove the need to fully disassemble the actuator at the final stage of manufacture and no sealant is applied, to ensure ease of removal. The dimensional tolerances of each segment result in a gap between the segments of 1.6 mm to 0.7 mm on each side (Figure 4) when installed into the upper piston (Figure 5).

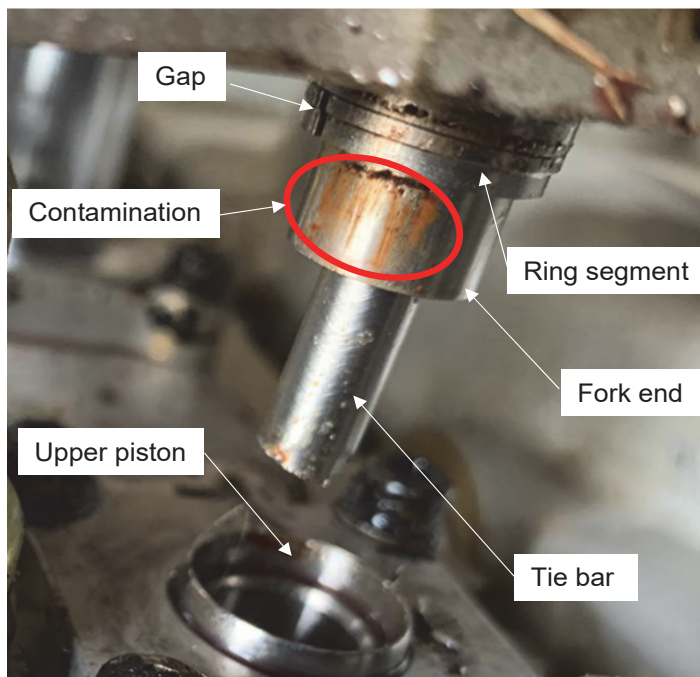
Figure 5
Compression ring segments gap

Analysis of the material found adjacent to the fracture on the tie bar (Figure 7) revealed a high sodium and chlorine content, amongst other chemical elements, with similar deposits found on the other actuator tie bars. There was evidence of the same material on the part of the fork end located within the upper piston (Figure 5).

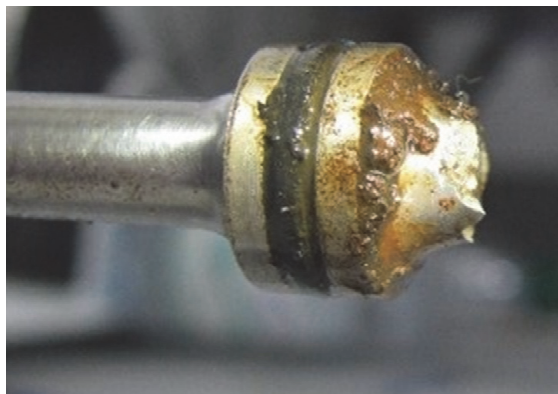
Figure 7

Material adjacent to tie bar fracture surface

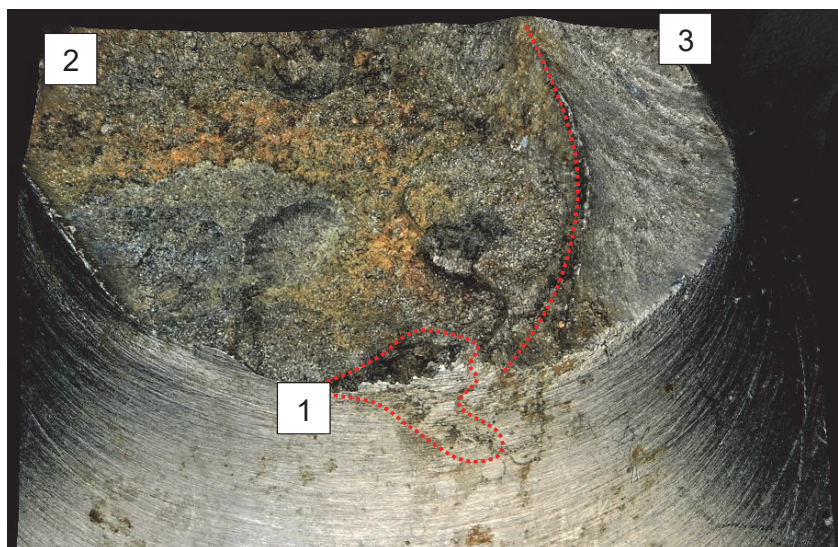
Figure 8

The failed tie bar was removed from the actuator and the fracture surfaces were examined using Scanning Electron Microscopy with semi-quantitative Energy Dispersive X-ray (SEM-EDX) spectroscopy (Figure 8). On the surface of the tie bar local to the fracture there was evidence of pitting corrosion, with several pits extending into the material [1]. On the fracture surface there was evidence of intercrystalline corrosion with crack propagation covering approximately $\frac{3}{4}$ of the fracture surface and the fracture surface was lightly corroded [2]. The remaining region of the fracture surface demonstrated failure through overload [3]. The tie bars from the lateral and collective axis actuators also showed evidence of surface pitting corrosion but to a lesser extent. Pitting corrosion was also identified on the internal bore of the upper piston coincident with the location of the failure in the tie bar.

Microscope photograph of the fracture surface (Airbus)

Following this accident, where longitudinal control of the helicopter was lost at low level, it was discovered that a tie bar within a main rotor actuator had fractured. This fracture was caused by the reduction in area of the tie bar through the propagation of a crack initiated by pitting corrosion. It is highly probable that the corrosion pits were caused by the accumulation of salt moisture in the end of the actuator, which had penetrated into the actuator through a gap.

To issue instructions for continued airworthiness in the form of a mandated (by EASA EAD) Alert Service Bulletin to inform all operators to inspect the main rotor actuators. If evidence of tie bar corrosion is found, or the time in service exceeds a defined period, then the tie bar is to be replaced.

To initiate a review of the actuator design with the equipment supplier to identify changes that could be made to prevent moisture ingress and a corrosion-initiated failure of the tie bar.

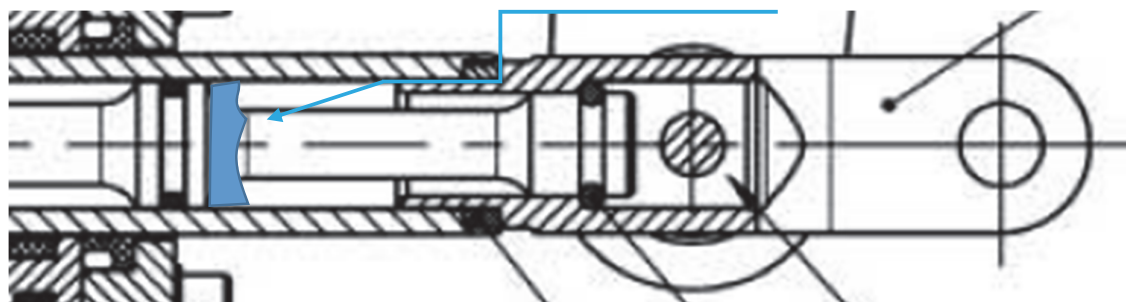
Figure 9

The combination of the installation orientation of the main rotor actuator and an unsealed gap between the compression ring segments could lead to moisture penetrating into the upper piston. This moisture would then collect by the first 'O-ring' seal at the end of the tie bar and, over time, cause the tie bar and piston to corrode. Analysis of the material found adjacent to the fracture surfaces showed elevated levels of sodium chloride. The helicopter's normal operating environment over the Cayman Islands and its waters would expose it to high levels of salt. It is likely that this deposit caused the pitting corrosion found on the surface of the tie bar. The deposit would then cause further corrosion within the material along the intercrystalline boundaries. Normal operating loads on the tie bar would cause these small intercrystalline corrosion cracks to coalesce, leading to a reduction in cross-sectional area. This would happen gradually over time, as evidenced from the light corrosion seen on the fracture face in VP-CPS. Finally, the remaining material would fail through overload.

Possible moisture ingress path (rotated)
